# Leica Geosystems **TruStory** Monitoring pays off

#### **Smallest Movements Determined from Precise 3D Data**

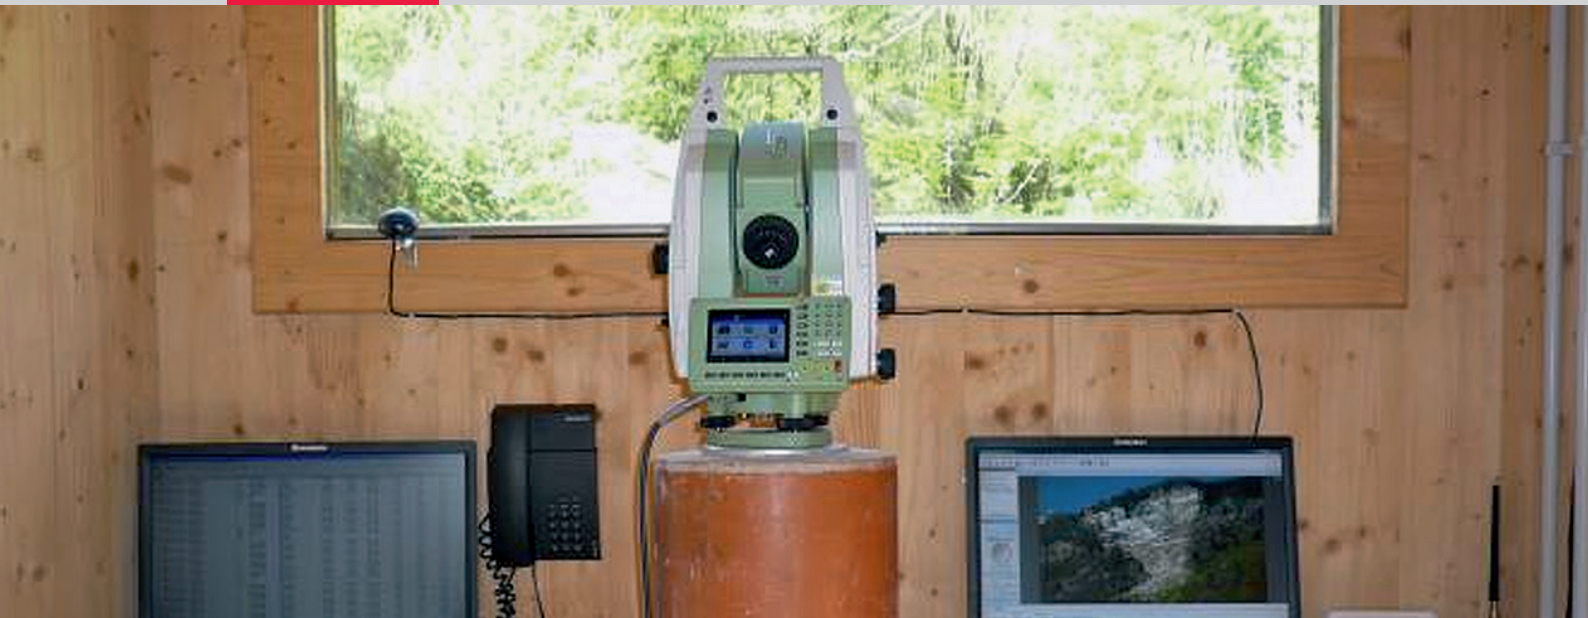
every movement in the affected zone. Two years ago a Leica TM30 Monitoring Sensor was installed on a stable pillar below the slide area and connected to the Leica GeoMoS monitoring system. Since then the sensor has monitored 15 observation points located inside and outside the danger zone every hour, 24/7. The results are automatically forwarded to an FTP server in the Forestry Department and then analyzed by experts.

data with millimeter-accuracy in real-time, knowing when movements took place and in which direction. The responsible experts were able to analyze developments and trends, and combined this data with additional information. The complete measurement history is very valuable to the geologists' further analysis."
