Leica Geosystems **TruStory**

Automated Deformation Monitoring

Apollo Bridge, Bratislava, Slovakia

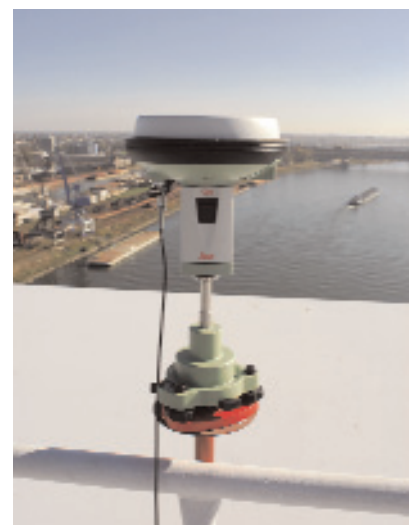
Leica Viva GS15 GNSS receiver on top of the bridge arch.

The GNSS Leica Viva GS15 was to static mode measurement and receiving data at an update rate of 1 Hz was used to determine the horizontal displacement of the top arch. All the data was stored in the internal receiver's memory (SD memory card). The Leica Nivel220 inclinometers, registered with 1 Hz frequency were used to determine the longitudinal and cross inclination of the bridge. The vibration of the bridge deck was monitored by one-axial accelerometers HBM B12/200 (in vertical direction) with a sample rate of 10 Hz.
