Superstorm Sandy Recovery

by Angus W. Stocking, LS

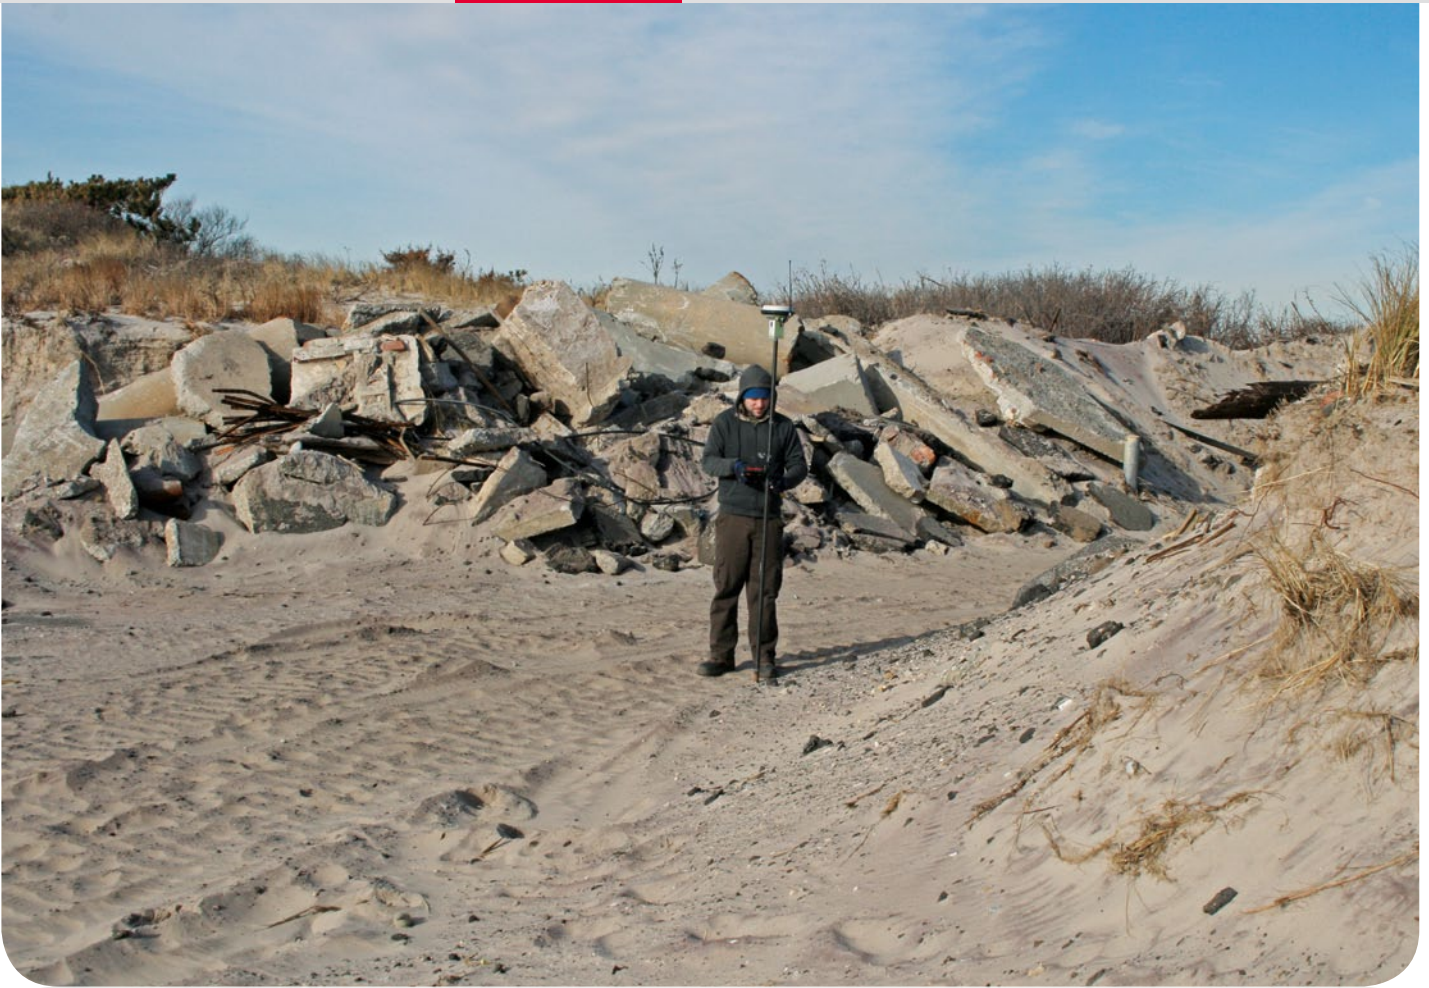
■ A GdB field crew uses a Leica Viva GS15 to survey post-Sandy beach erosion for the town of Oyster Bay.

find the village's missing sand. Saltaire is a village on Fire Island, another of Long Island's barrier islands, and it's one of the few Long Island communities that can only be reached by boat or on foot. Sandy wiped out dunes that the village depends on to protect residential areas from tides and erosion, so a beach section survey was needed to find areas where sand could be removed for dune reconstruction. By law, sand can only be repositioned if it's above a defined elevation. Sand is so important to Saltaire that the mayor got involved and even made a site visit. But the mayor didn't like what the survey said. "We had to tell him, 'No sand'," says Gayron. "Sandy washed it all away."

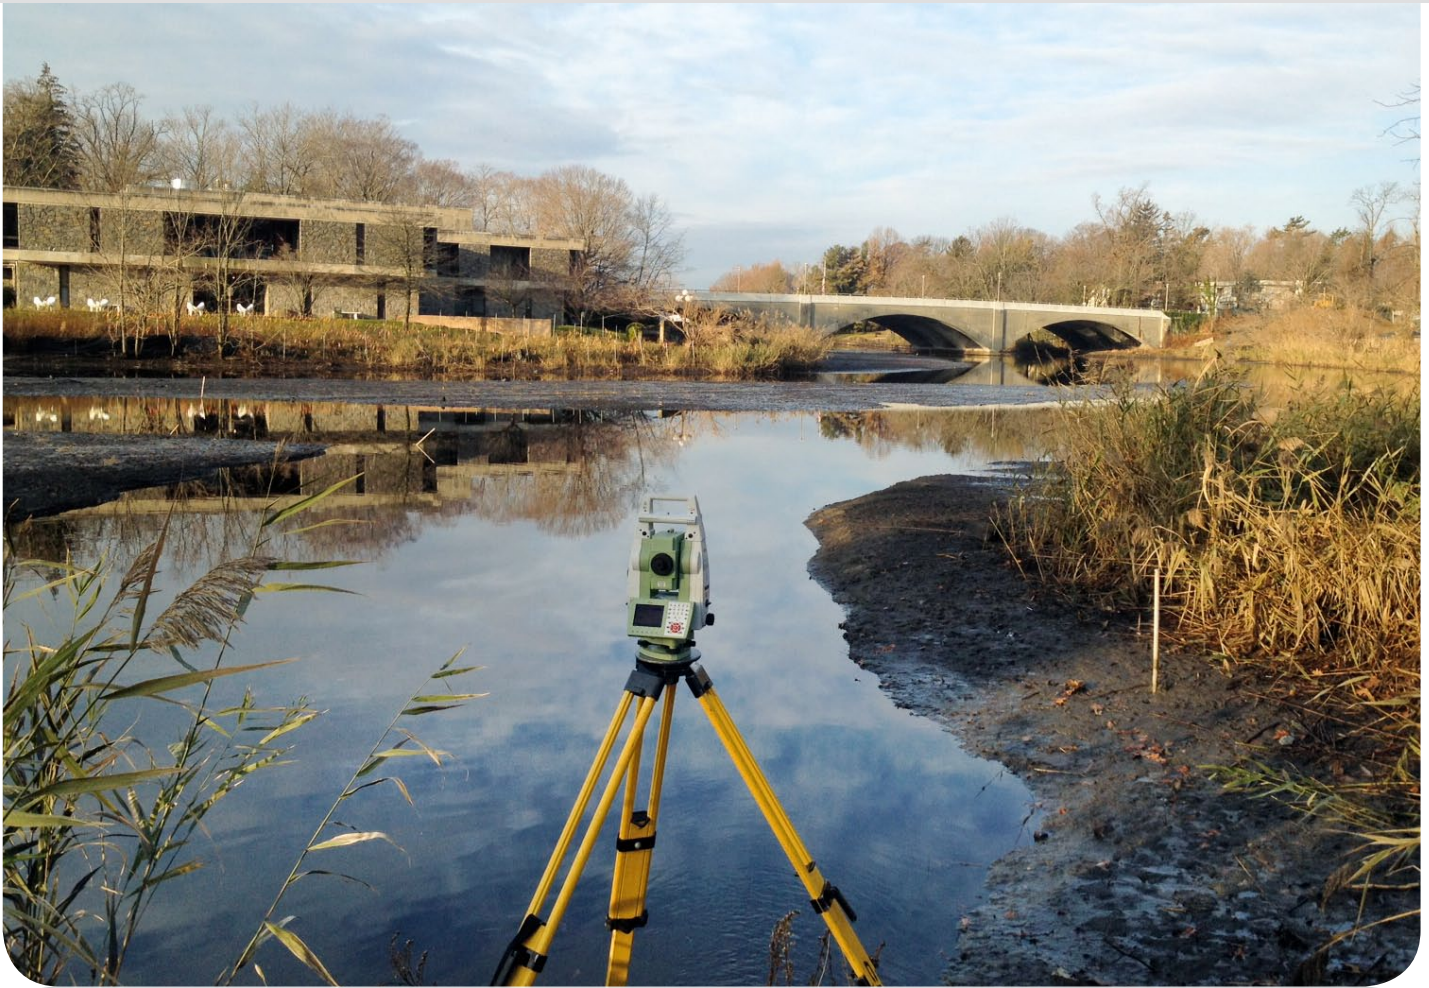
■ A Leica Viva TS15 is used to survey Udalls Pond in Nassau County to determine the sedimentation effects of Sandy.

Nassau County also called, worried about their mud. "We've been doing pre-dredge and post-dredge surveying for the county since 2008," Gayron explains, "monitoring sediment buildup in the pond and near a bridge. Basically, they were wondering if four years of work had been undone."

The "pond" is Udall's Pond, a 230-acre, tidally influenced wetland area. It's muddy, but most of the hydrographic work can be done with a boat or from

the bridge. In some areas, GdB was forced to use a "custom pond-crossing gadget," which is essentially a sled with a Leica Geosystems prism attached; crews towed the sled across areas of thick mud to capture profiles of surfaces that defied walking and boating. Using these methods, GdB was able to show that sediment hadn't returned to dredged areas, and around the bridge (desirable) sediment buildup had actually increased. "It was nice to deliver some good news for a change," says Gayron. ■
