Leica Geosystems **TruStories** Monitoring

Leica Geosystems **TruStory**

Track Monitoring

Traunstein, Germany

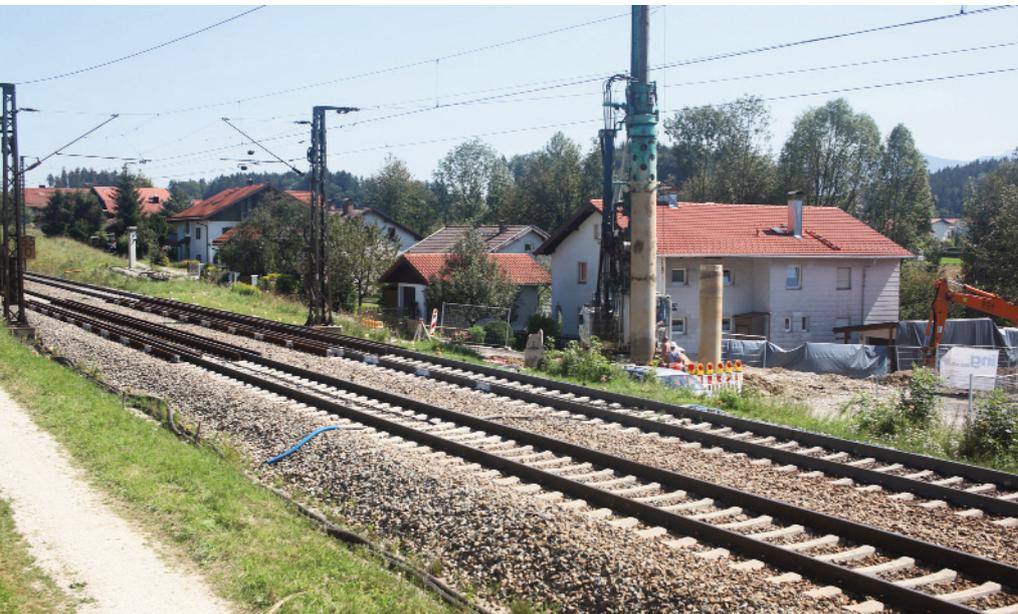
Munich-Salzburg railway line above the tunnel site

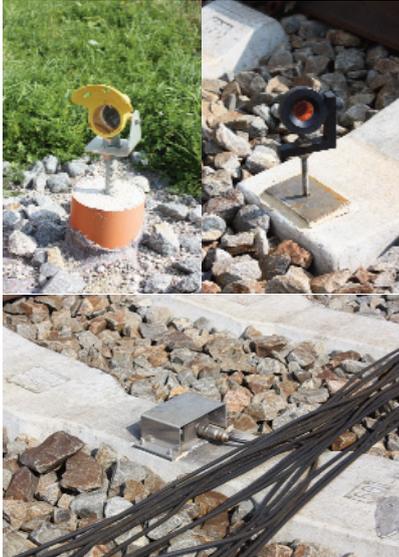
Leica GPR112, Leica GMP104 prisms and tilt sensor

Measurements are taken per hour. In addition to these measurements, tilt sensors mounted on the sleepers also monitored track movement. All the captured data were transferred almost in real-time to a GeoMoS computer and visualized for the customer with the help of GeoMoS Web.

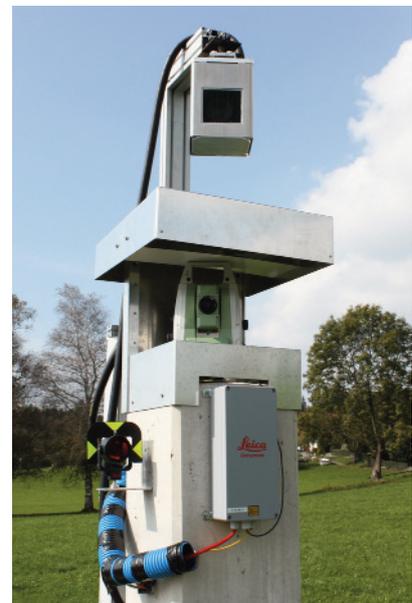
Measurement pillar with Leica TM30 and webcam

Since the start of the project the in Traunreut engineers used two Leica TCA1800 total stations for monitoring. These traditional monitoring instruments impressed the engineers with their robustness and reliability. To prepare for future monitoring projects with similar or higher requirements, in Traunreut GmbH decided to test the new Leica TM30 monitoring sensor in this role. After completion of the first monitoring phase, one of the TCA1800s was replaced by a Leica TM30. The new model remained in operation throughout the entire second monitoring phase, during which time it made a big impression, measuring almost silently with its new piezo drive capable of higher rotation speeds, whilst achieving improved accuracy over a longer range. It also offers two very use-

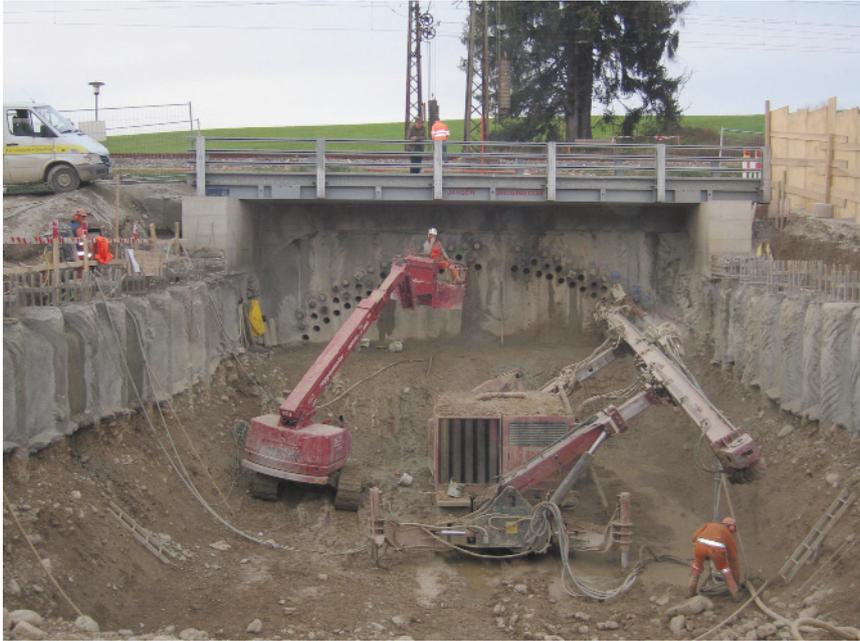
Installation of pipe canopy tunnel lining (monitoring phase II)

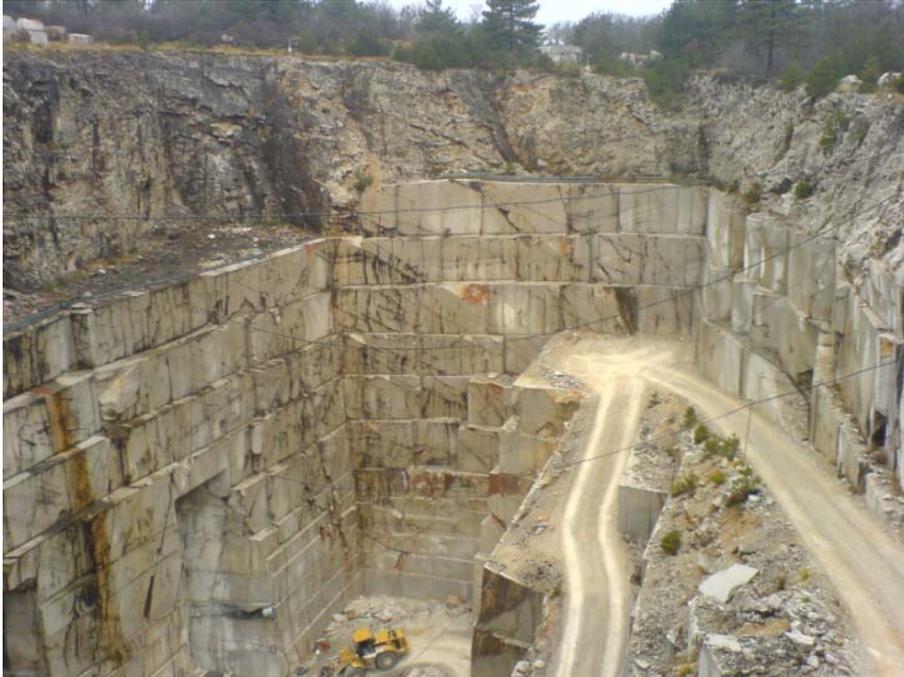
Lipica II quarry. The underground entrance is 60 m below the surface.

The terrain around the quarry is compacted with a lot of cracks. There are also numerous caves and caverns. The region also experiences freezing temperatures and high rainfall, which have led to erosion, rockslides and breakages of rocks around the edge of the open cut pit.

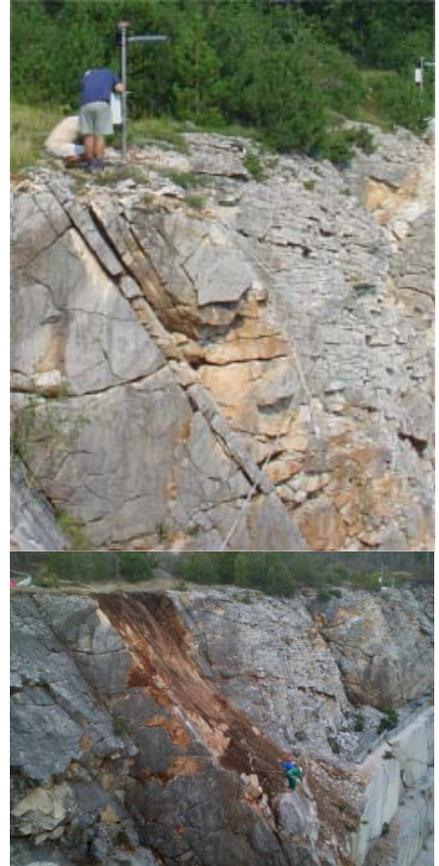
Before and after photos of the area around monitoring point 2.

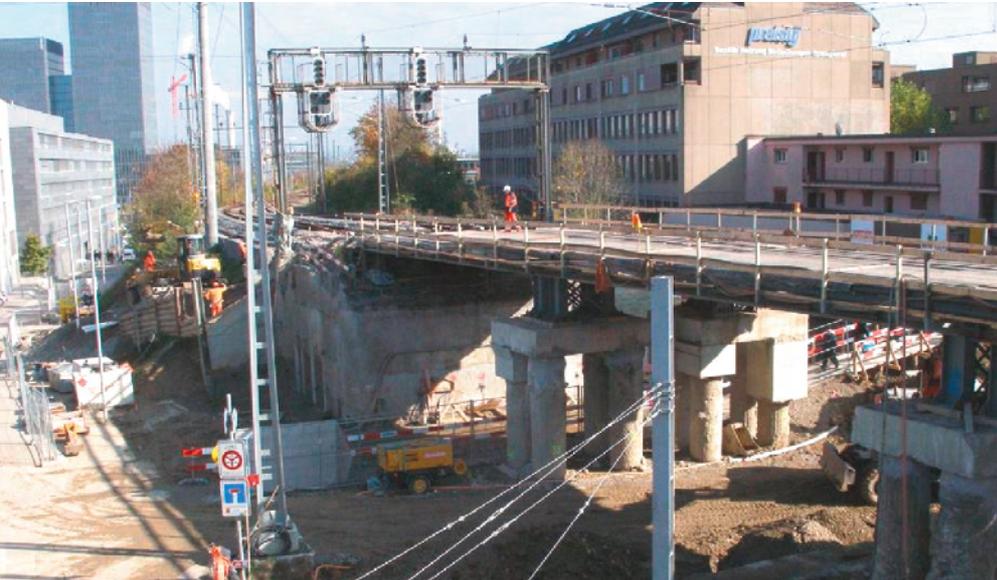
Reconstruction of the 100 year old railway bridge carrying two railtracks.

During 2008 and 2009, a 100 year old bridge close to the Oerlikon Railway station was renovated. The old steel construction was replaced by prestressed ferroconcrete and the span width was increased from 15m to 38m. In order to excavate the existing bearings, pillars, undercrossings and rail dam on the eastern side, assistant bridge elements were constructed. These temporary bridges lay 80 cm higher than the old tracks and created the required space to build the new bridge.

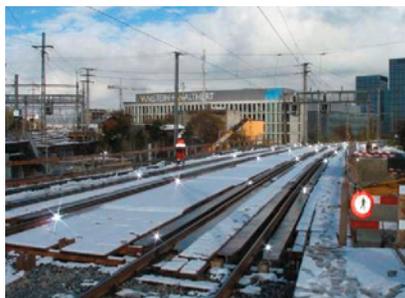
Monitoring prisms on the temporary bridge for deformation tracking.

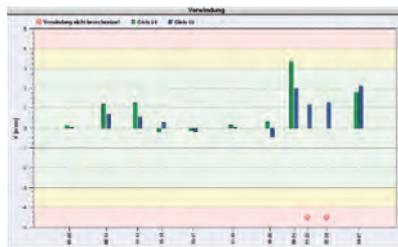
Torsions at the different sections show when they exceed the two limit classes.

In order to monitor the torsion of the track, inclination values were computed from the settlement measurements. Using 2 settlement measurements at one cross section results in one inclination computation. Comparing this inclination to the next inclination value along the track you get the torsion value, indicating the change along the track axis.

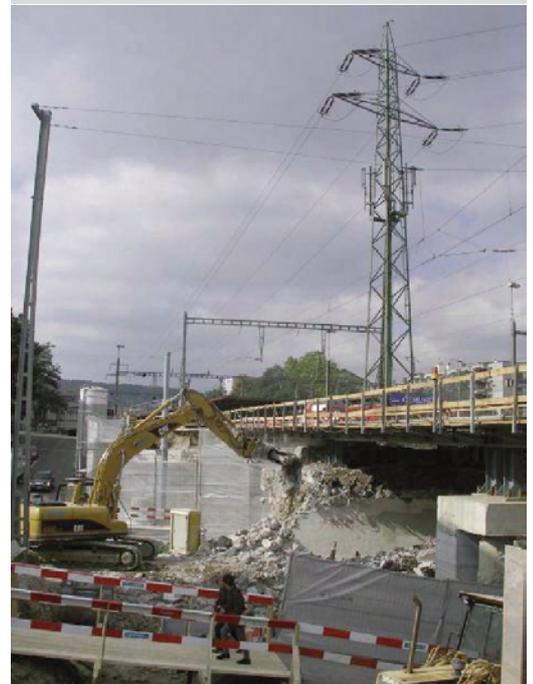
During demolition of parts of the foundation of the power line pylon, the monitoring system was used to detect 3D deformations and the resulting change in tilt.

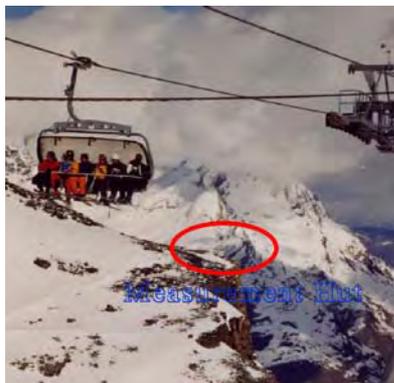
There are two prisms mounted on each of the 12 supports. On the top station building there is a reference point that is used to adjust the orientation of the

system. An Excel Macro is used to analyze the displacement of all supports in plane, height and rotation. All the equipment is powered by one solar panel. All points are measured in the ATR mode for highest accuracy, with the furthest point at a distance of about 1200m. In the near future, a new window will be installed with integrated heating to eliminate ice and snow on the glass.

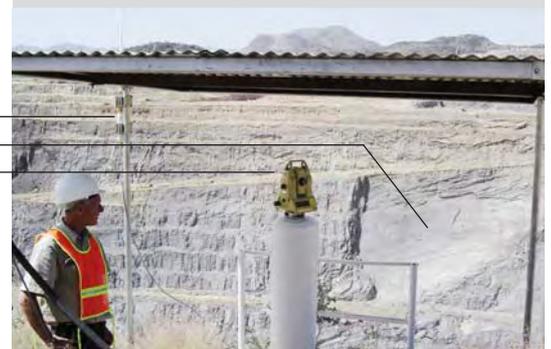
EDL radio modem
Previous slope failure
Leica TCA2003

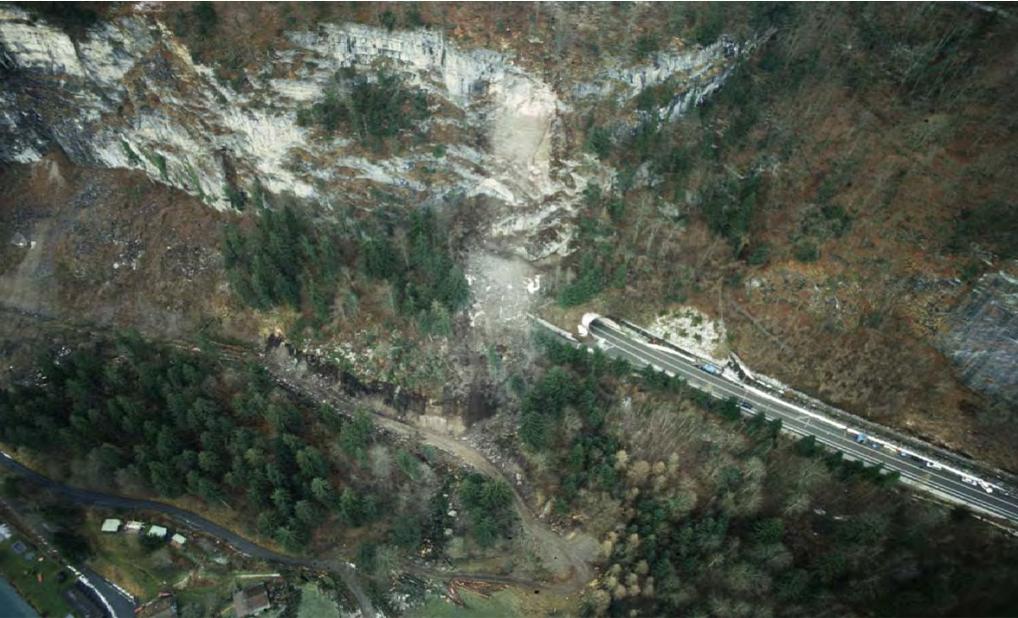
In January 2003 there was a fall of approximately 150 m³ of rock from above the Chüebalm tunnel in Iseltwald/Interlaken. The falling rock punctured the tunnel near the western entrance and blocked the highway.

After this event two instable rock masses were blasted to help prevent a recurrence of the rock fall. In addition the tunnel roof was repaired and reinforced and a protective dam was constructed above the exposed village. During the reconstruction work two monitoring systems (Leica GeoMoS and a geotechnical system) were used to measure the movements of the rock face. The monitoring systems were used to ensure the safety of the motorists on the highway and the construction workers. If a tolerance is exceeded or a system error occurred, warnings were sent to

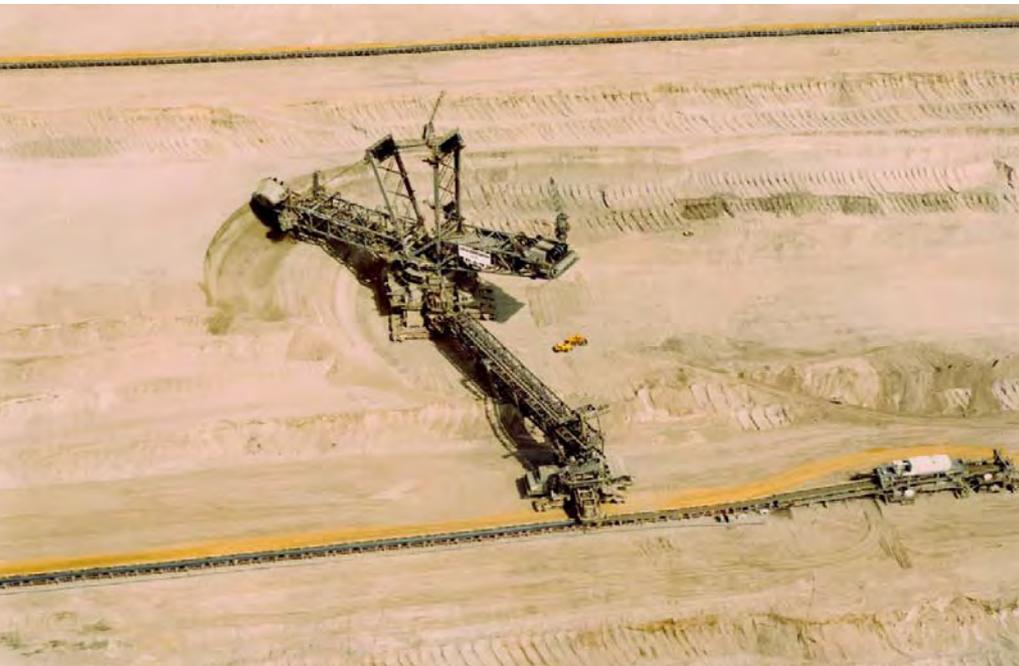
Die durchgeführten Messungen geben Aufschluss über die Bewegung der Böschungsoberfläche. Am zeitlichen Verlauf der Messwerte kann in einem Weg-Zeit-Diagramm erkannt werden, ob es sich bei den gemessenen

Bewegungen um normale Entlastungsverformungen oder möglicherweise beginnende Bruchverformungen handelt. Bruchverformungen gefährden die Standsicherheit von Böschungen und erfordern angepasste Sicherungsmaßnahmen. Die Beobachtung bzw. Kontrolle von Böschungsverformungen sind ein unverzichtbarer Teil der Standsicherheitsbeurteilung von großen Tagebaurandböschungen und sind daher wichtige Komponenten einer modernen Tagebautechnologie.

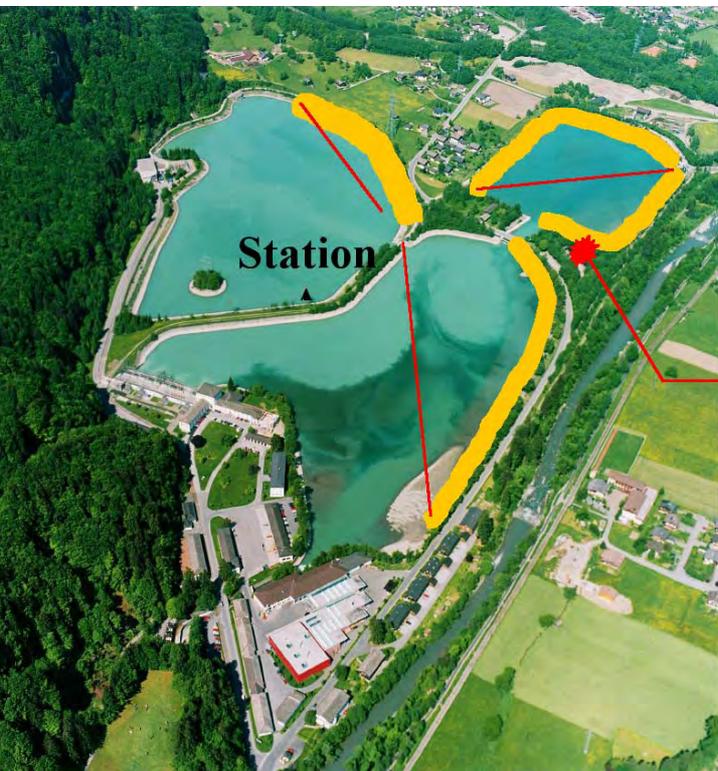
Station B

Aktiver Erdfall

Auf Grund des speziellen geologischen Aufbaus (Illschotter über wasserlöslicher Schicht) besteht im Bereich der Speicherseen beim Kraftwerk RODUND Gefahr des plötzlichen Einbruchs der Erdoberfläche.

Durch solche Ereignisse können zwei Häuser und die Dämme der Seen gefährdet werden. Da die Erdfälle, wie diese Einbrüche genannt werden, mit Geschwindigkeiten von bis zu einigen Metern pro Stunde erfolgen können, ist eine permanente Beobachtung aller Punkte notwendig, um im Ernstfall rasch reagieren zu können.
