Leica Geosystems **TruStory**

Safely renovating ship locks

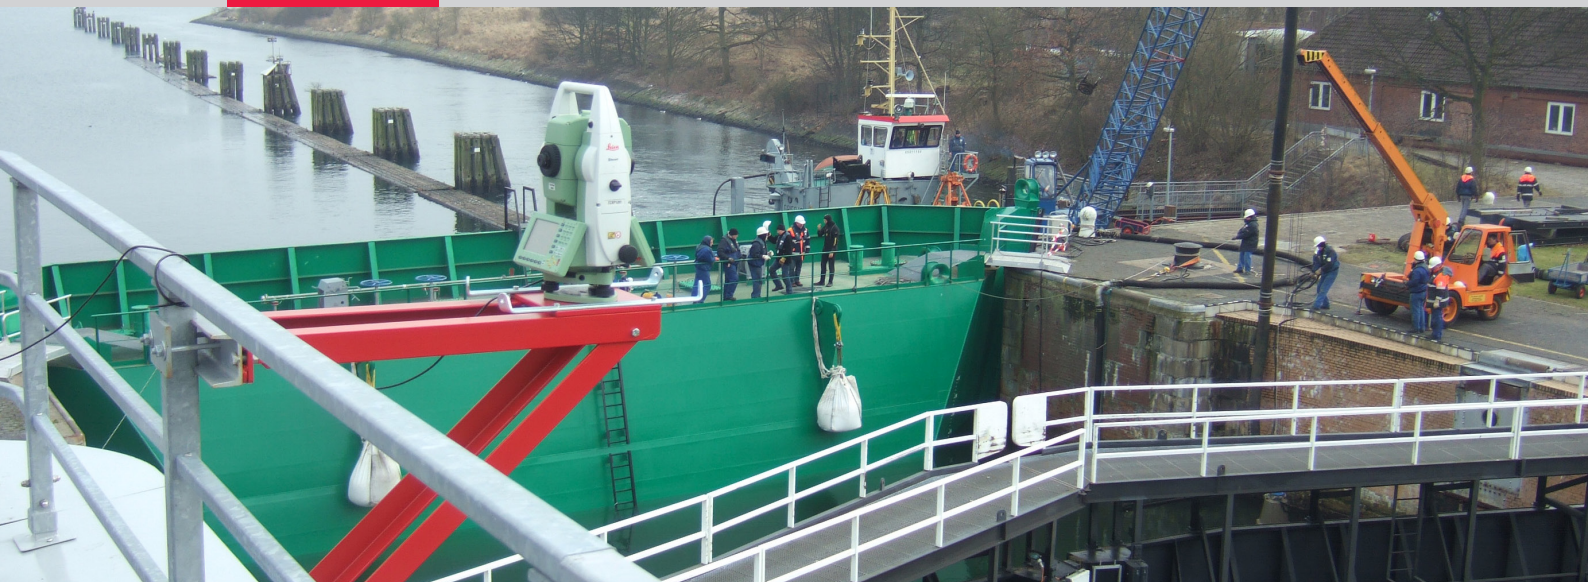
The Leica TCRP1201 total station, connected to the Leica GeoMoS monitoring software for data collecting and processing, was installed on top of the lock's control station, located on the partition wall of the two lock chambers. Since the location of the sensor was in an area subject to possible movement, the monitoring method known as free stationing was undertaken. This meant measuring six different stabilised reference points

attached to surrounding buildings in the area that were not subject to movement in order for the hourly program-controlled data measurements to be possible. The measurement points on the lock were then determined in 3D. In this way, the ten measuring points from which the chamber width can be derived, served as "virtual sensors". These hourly measurements of the north and south sides of the chamber walls, as well as the control of the fjord and chamber water levels, was carried out using the highly customisable Leica GeoMoS family software programs. In addition, the coordinates of the six head-base points, the three chamber-base points and the two points on the inspection covers were also recorded. The values of each of the six groundwater measuring points on the north side and the south side, as well as the level of the fjord and chamber water level, were recorded hourly and transferred to the GeoMoS software.
