Leica Geosystems **TruStory** Slope Monitoring at Adaro Tutupan Coal Mine/Indonesia

Monitoring the open cut coal mining slopes' deformation to predict the time of slope failures and to protect personnel and equipments from slope failures

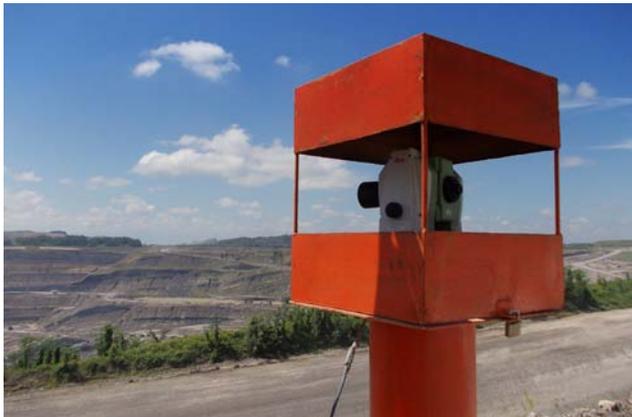
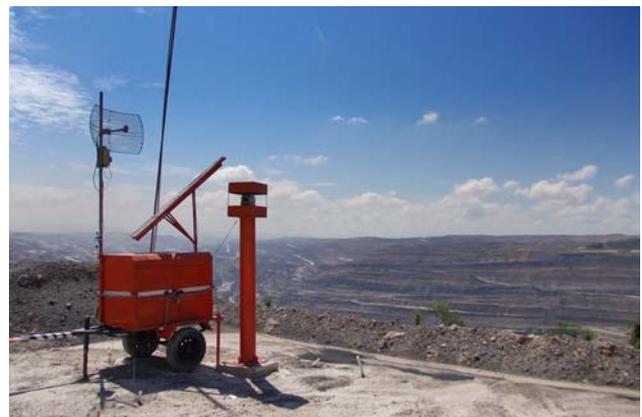
A combined power supply station with a solar panel is used for data transmission to the main office for data analysis (top).

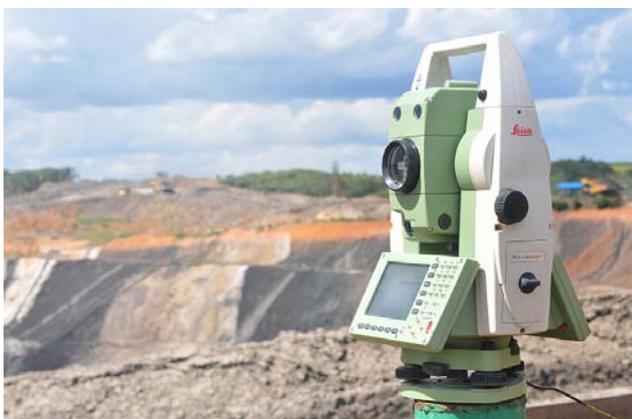
Several High-Precision Leica Geosystems total stations are used to monitor the slopes of the Adaro Tutupan Coal Mine (left).

Currently, 11 Leica Geosystems total stations with hundreds of monitoring prisms are installed in the pit slopes to perform slope stability monitoring. The monitoring prisms are installed on the slope surface with intervals of 100-150 m and the process of installing many more prisms to cover all the pit slopes is ongoing. The total stations measure distances between 800 and 2500 m in a nearly continuous measurement cycle.
