Leica Geosystems **TruStory**

The Great Ancona Landslide

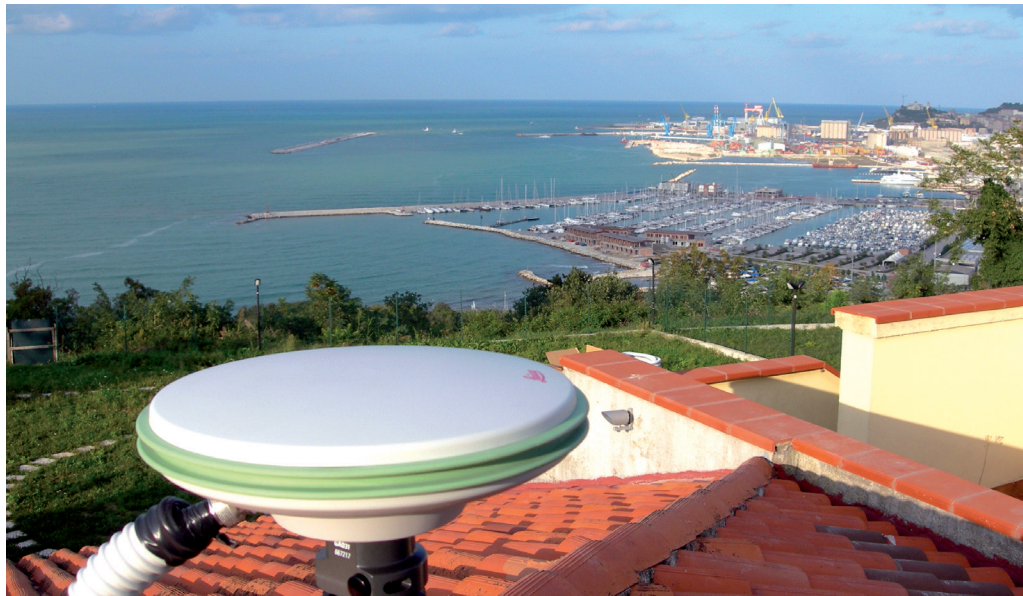
Each station in the 1st and 2nd level network was installed on reinforced concrete piles. Each pile is 1 meter in diameter, sunk into the ground to depths varying from 10 to 25 meters, with about 3 meters above ground level. Each concrete pile has a Leica TCA2003 robotic total station installed on top. The AX1202 GPS antennas together with the Leica GRX1200 GPS receivers were installed by means of stainless steel posts, 10 cm in diameter, with variable heights. Each station was completed with wiring for communication and power supply.

The 3rd level network stations, were created by installing single frequency GPS antennas and solar panels on the roofs of private homes. Each station was wired to protect the power supply and installed in positions allowing easy access for possible maintenance work. Approximately 200 prisms were installed on the homes in the area, for measurement by the seven Leica TCA2003 robotic total stations.
